Coastal Geologic and Engineering History of Presque Isle Peninsula, Pennsylvania

*by Richard J. Gorecki
U.S. Army Engineer District, Buffalo*

*Joan Pope
Coastal Engineering Research Center*

Final report

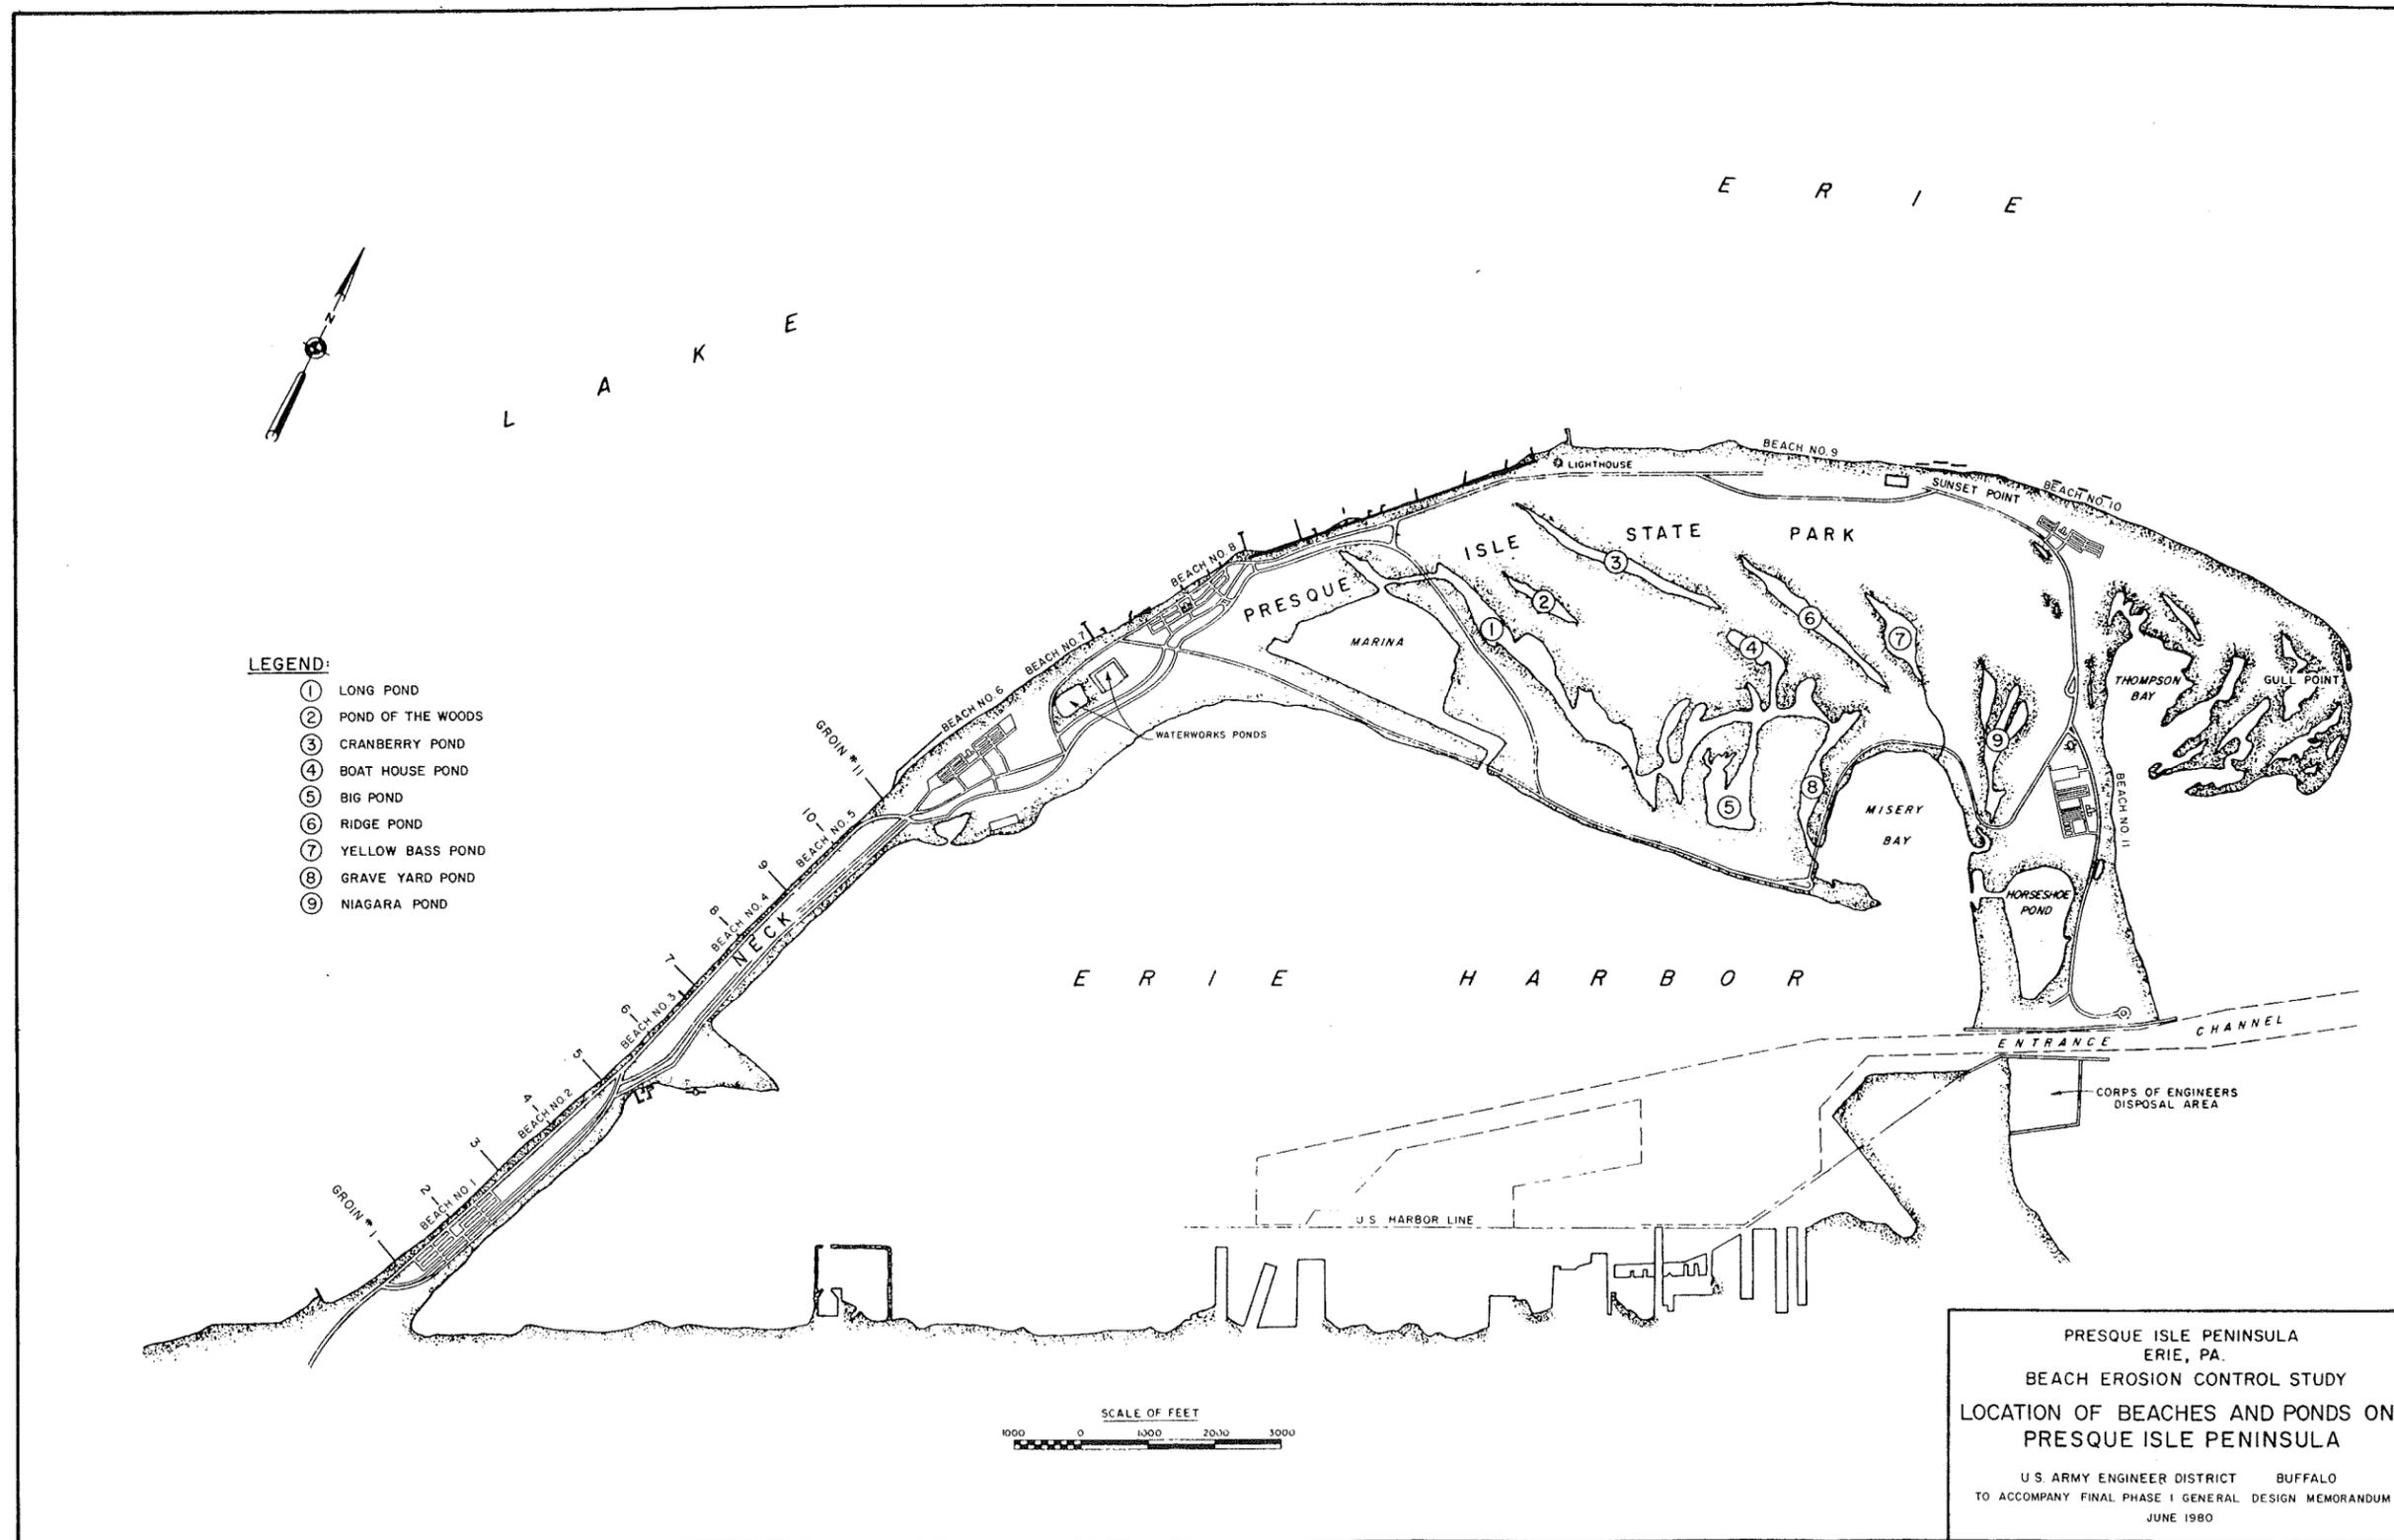
Figure 2. Location of beaches and ponds on Presque Isle Peninsula (USAED, Buffalo 1980)

The lakeward perimeter of Presque Isle is about 9 miles. The lakeward shoreline has been segmented into 11 bathing beaches by the Pennsylvania State Park Services. These beaches vary in width and, with the exception of Beach No. 11, have had a history of serious erosion for at least 160 years. The bathing beaches are backed by picnic areas, and five major beach areas are provided with bathhouse and parking facilities. Roadside parking provides beach access to intervening beach and picnic areas. Over the last 16 decades, numerous protective works consisting of groins, revetments, bulkheads, and offshore breakwaters have been constructed to halt erosion.

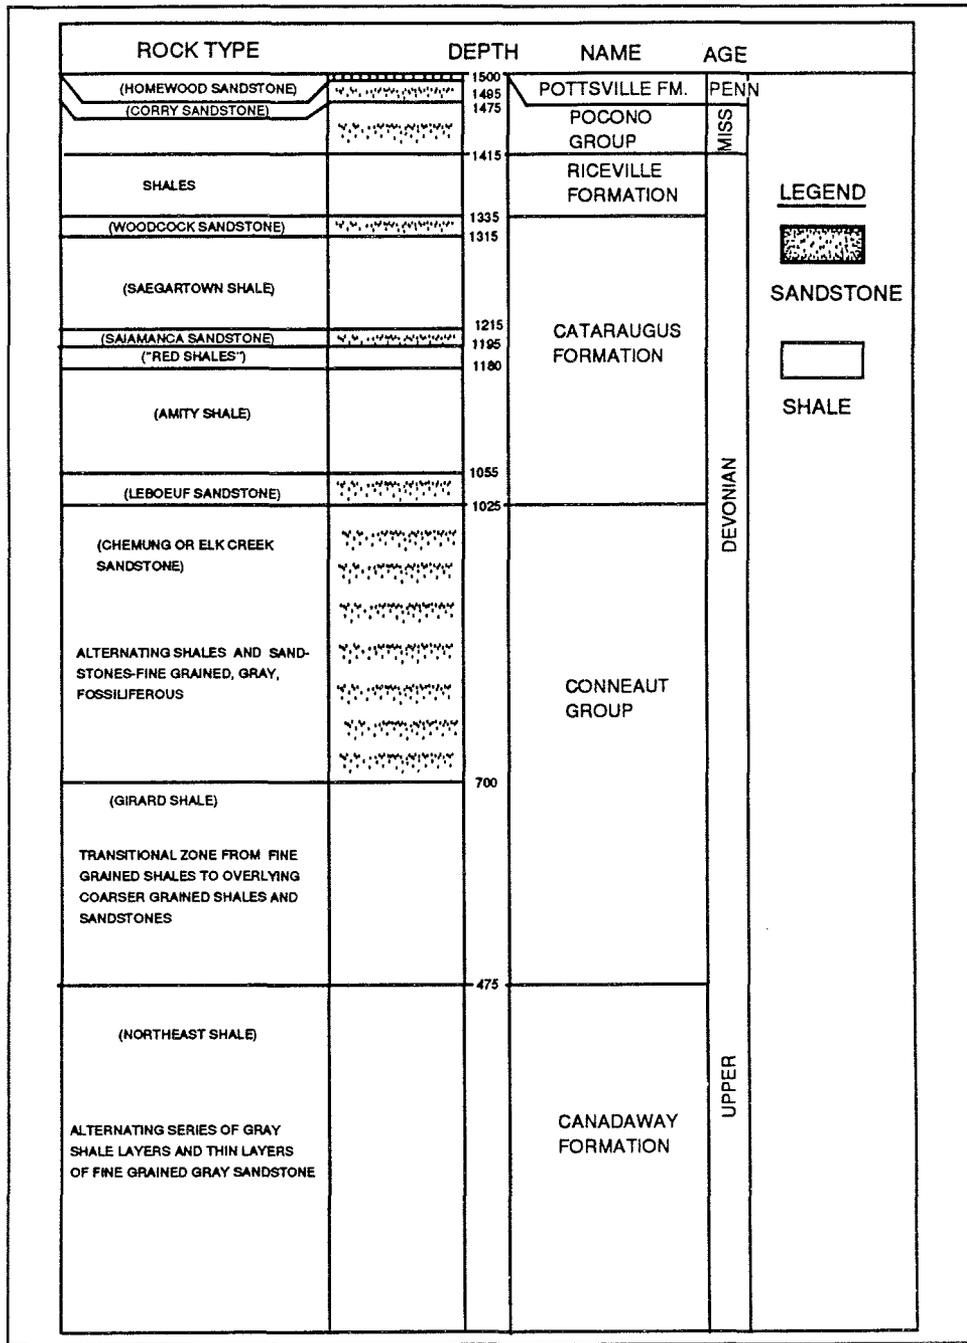
Figure 3. Bedrock exposed in Erie County Pennsylvania (modified from Tomikel and Shepps (1967))

Bedrock exposed in Erie County, Pennsylvania, is predominantly Upper Devonian shales and siltstones of the Conneaut and Canadaway Groups. Figure 3 is a geologic column of exposed rock. At Presque Isle, there is a lakeward slope of the rock surface with contours parallel to the mainland. At the junction of the neck of the peninsula with the general shore, the bedrock surface is only 2 ft below LWD. A gas well drilled near the northeast corner of the Waterworks ponds on Presque Isle (Figure 2) shows rock to be about 112 ft deep. Borings taken in 1965 by a consulting firm for the state of Pennsylvania extended in a line across the harbor entrance channel and showed that the rock surface sloped lakeward with a 1 on 125 slope and a depth approximately 60 ft below LWD near Beach No. 11 (Rummel, Klepper, and Kahl-Fertig Engineering Company 1968). The bedrock here is likely to be the gray shale of the Java Formation of the Venango Group (Socolow 1980).

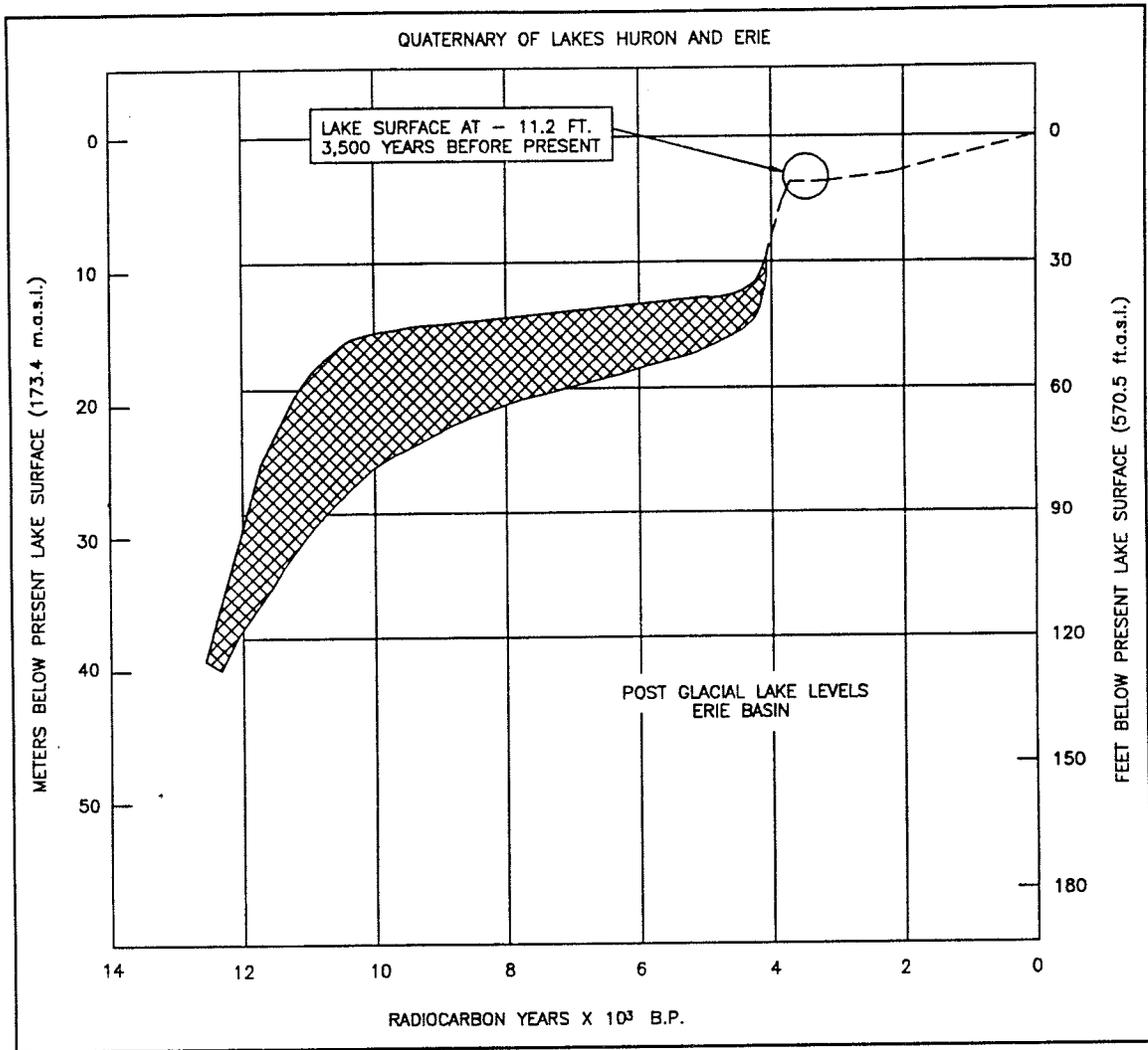
Figure 8. Post-glacial history of Lake Erie water levels (modified from Lewis (1969))

In another study of water levels, Lewis (1969) compared radiocarbon dates with known lake levels and developed the diagram shown as Figure 8. This shows the rate of change in water level in the Erie Basin during post-glacial time. Lewis prefers to use the curve near the upper envelope. If the lower curve is adopted, it would mean that levels in the eastern basin of the lake would have been lower than the channel along the southern margin of the Long Point-Erie Moraine for more than 1,500 years. Lewis' diagram also shows the steep rise of water from 5,000 to 3,800 years B.P. This initial rise corresponds to the abandonment of the North Bay, transferring more flow into the lower Great Lakes.

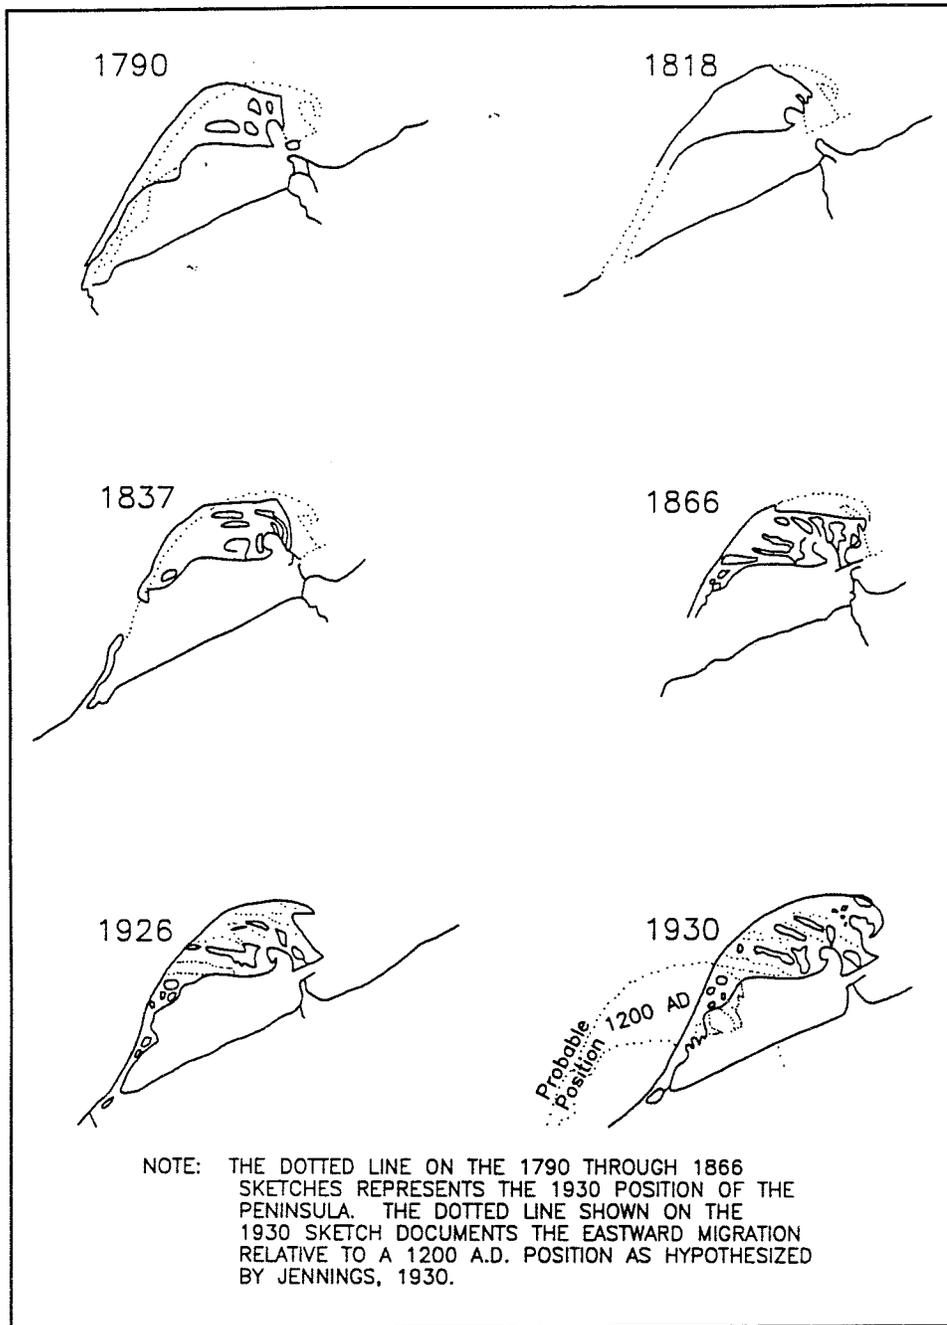
Figure 9. Growth and migration of Presque Isle (modified from Jennings (1930))

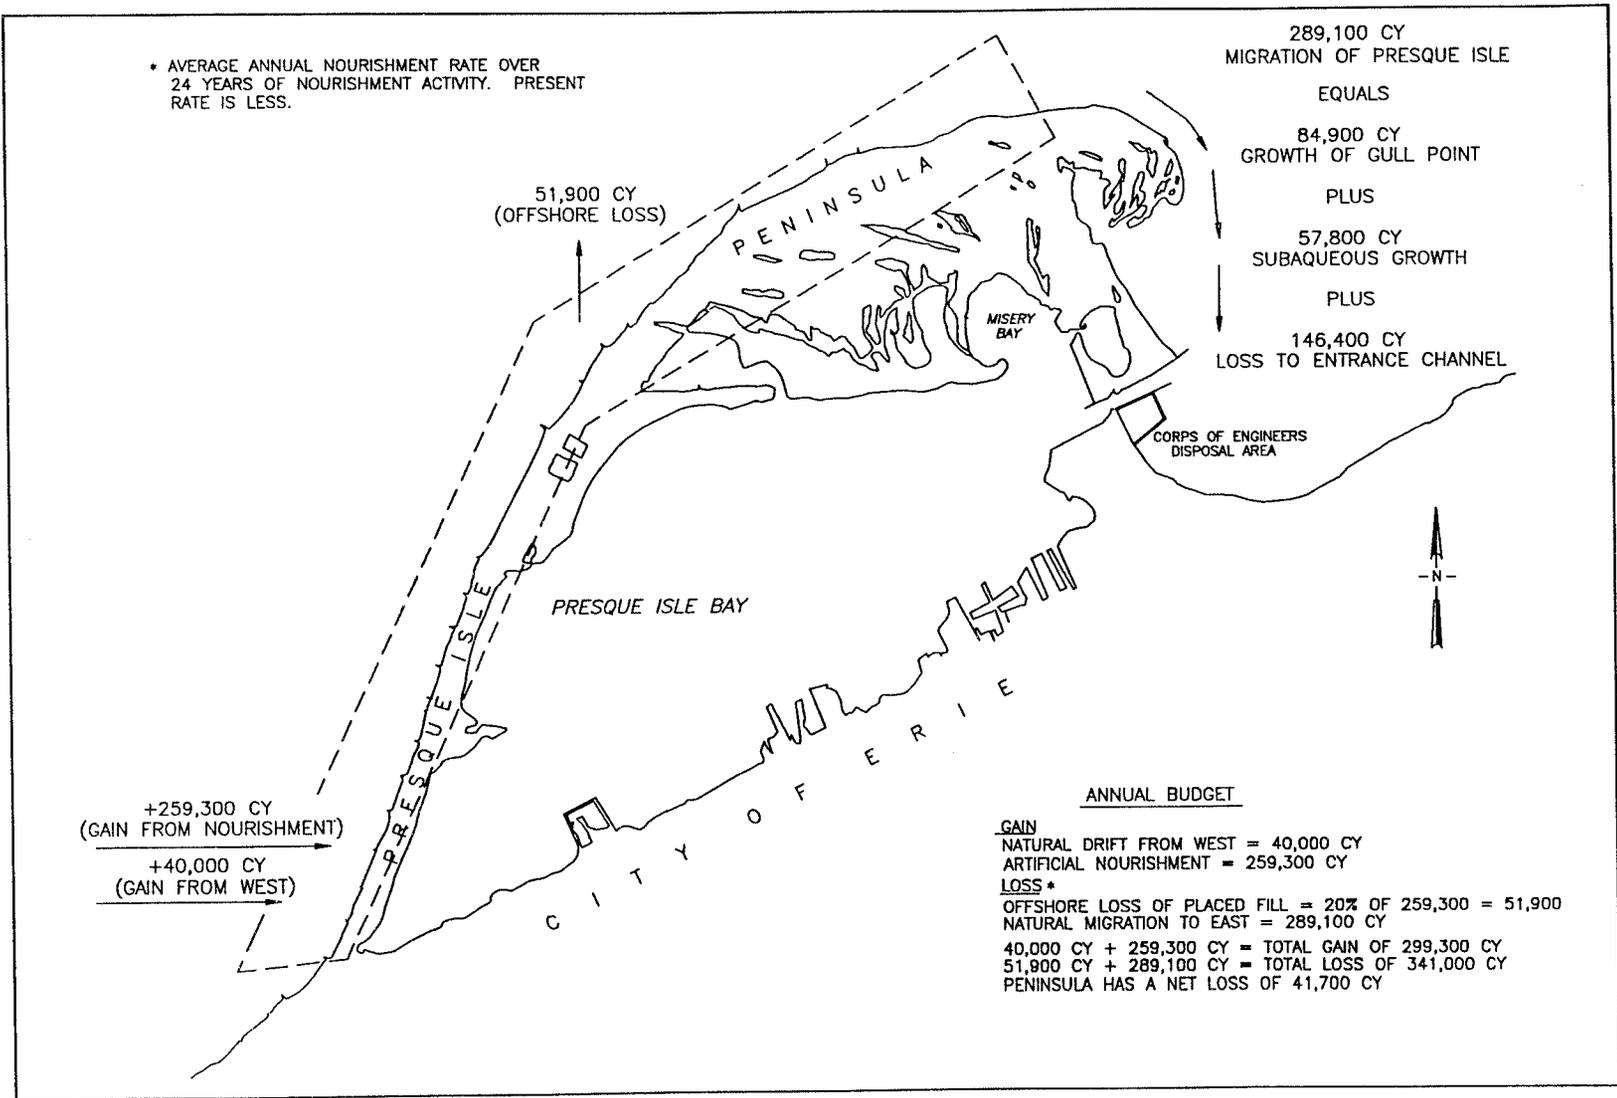
Figure 10. Present Presque Isle sediment with annual nourishment (modified from USAED, Buffalo (1980))

The main area of loss to the Presque Isle system is at the distal east end. Here the drifting sediment builds Gull Point, spills over the eastern end of the platform, building a new platform and is recurved shoreward and landward, shoaling across the Erie Harbor entrance channel. Estimates have been made to summarize losses at the east end based on historical changes at Gull Point, bathymetric charts, and dredging records for the Erie Harbor entrance channel (USAED, Buffalo 1980). Based on these figures, the present condition (with replenishment) is that an estimated 146,400 cu yd of littoral material accumulate in the entrance channel per year, 84,000 cu yd per year are involved in building Gull Point, and 57,800 cu yd per year build the new platform at the distal end (Figure 10).

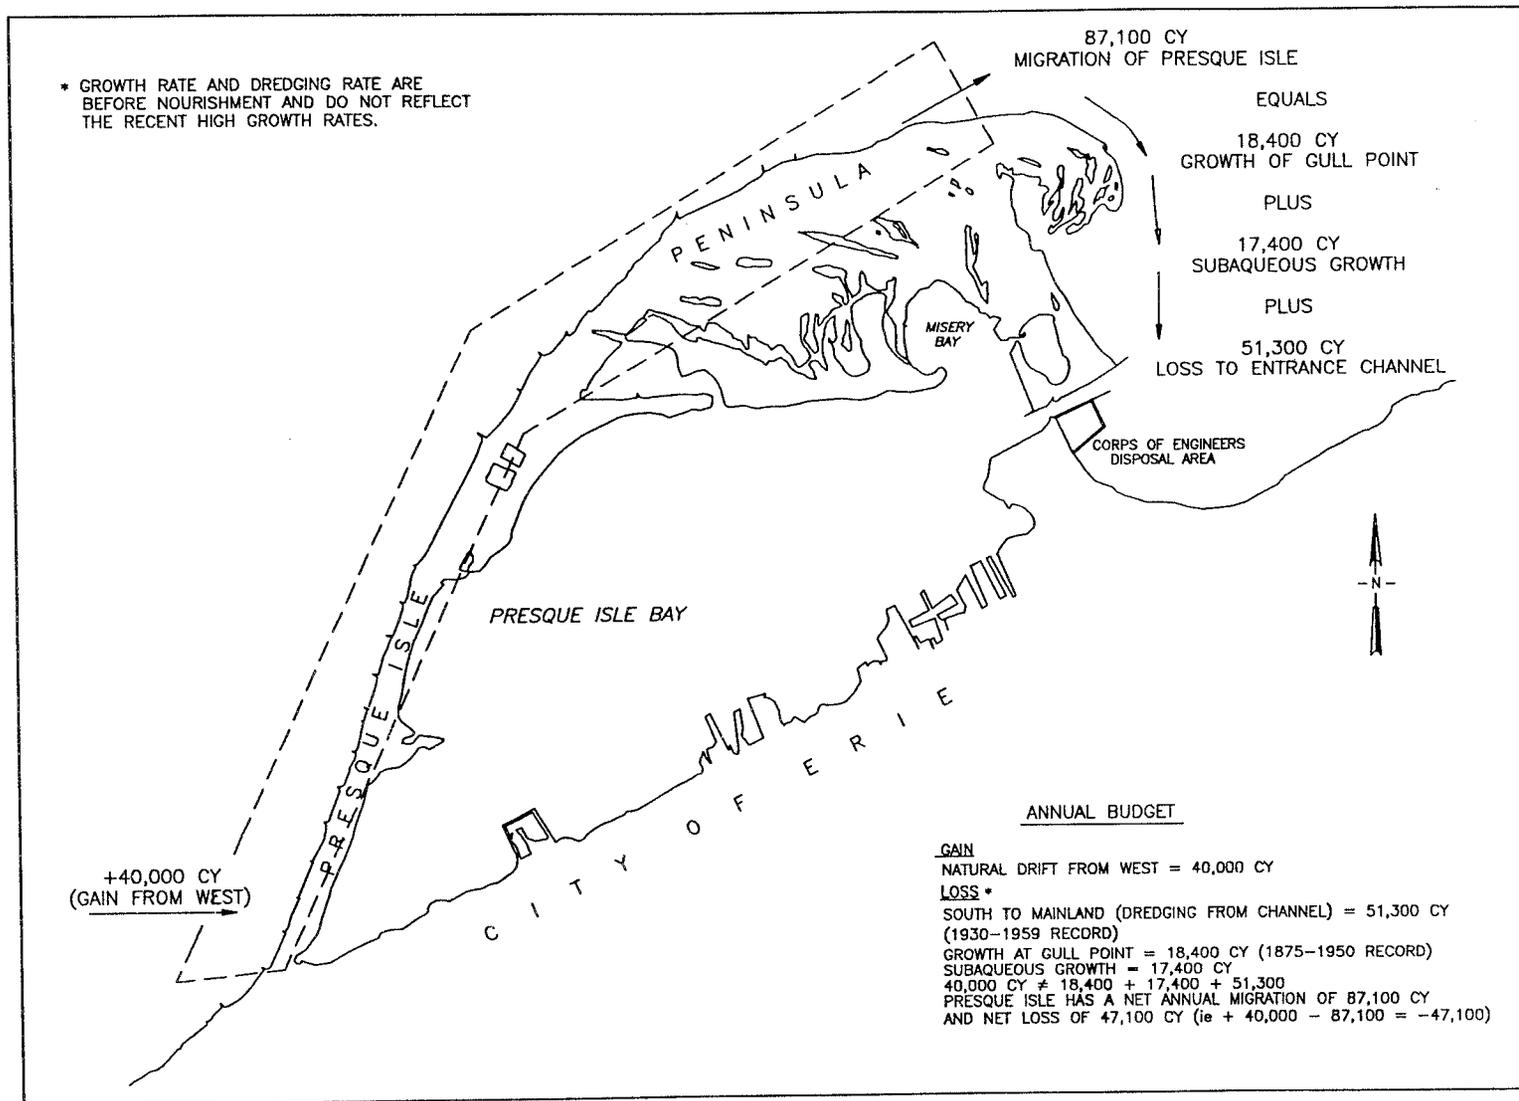
Figure 11. Presque Isle sediment budget without annual nourishment (modified from USAED, Buffalo (1980))

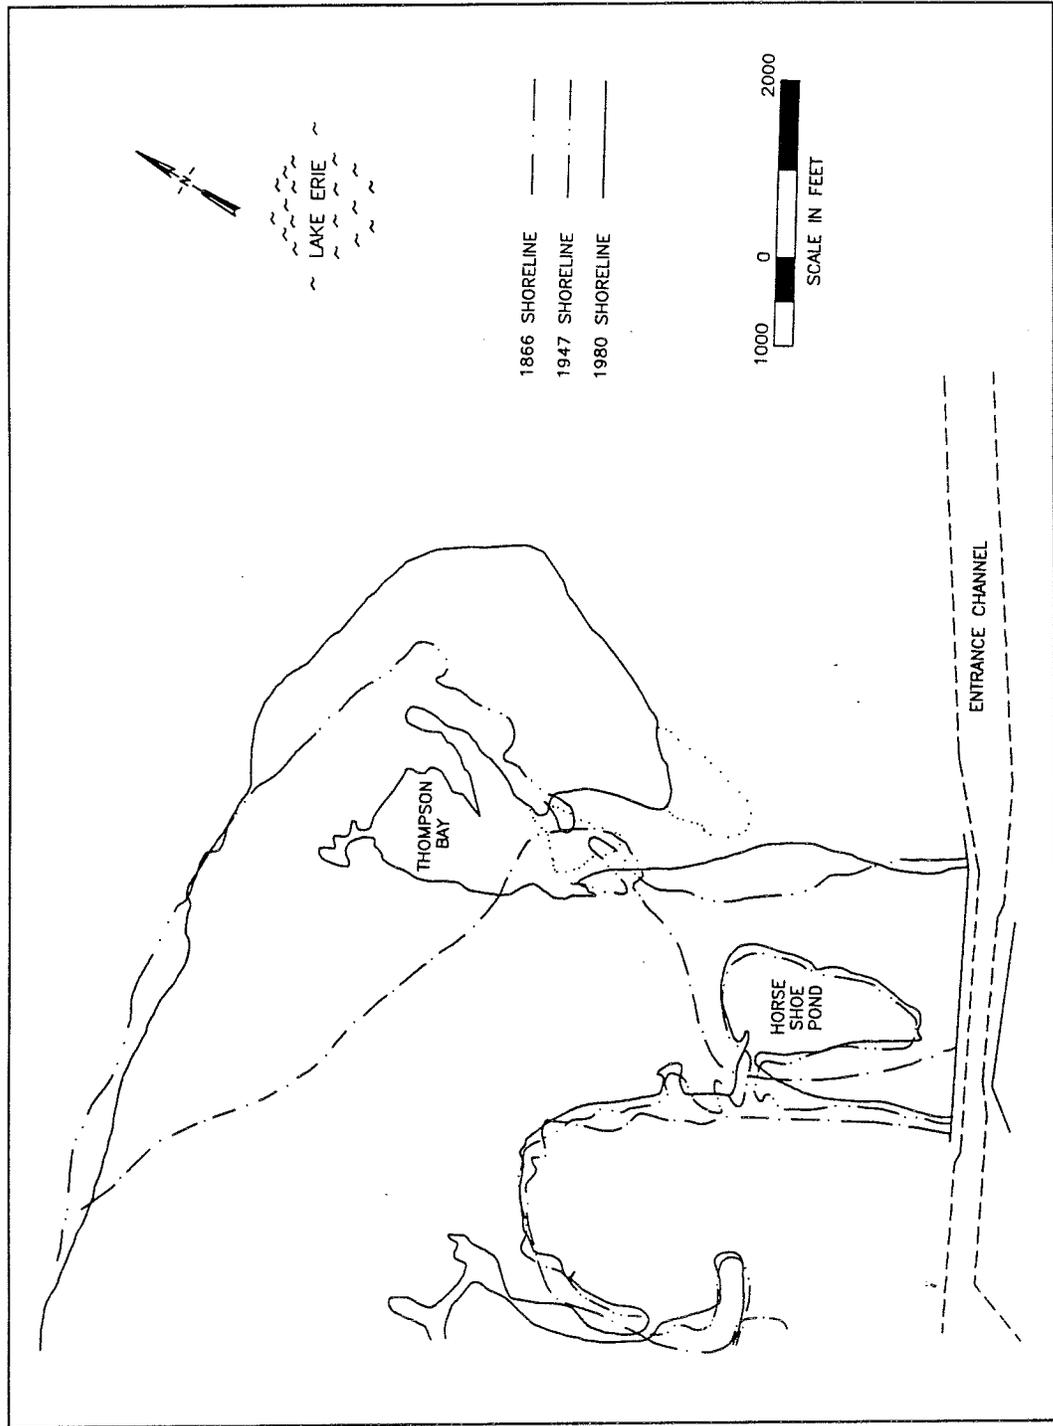
Figure 12. Presque Isle eastern 6-ft contour changes (1875-1980) (modified from USAED, Buffalo (1986))

material placed on the beaches ends up in the entrance channel. This will occur as Gull Point continues to migrate along an axis which intersects the entrance channel. The historical maps of the shoreline, and the 6-, 12-, and 18-ft below LWD depth contours which were originally presented in House Document 231 (U.S. Congress 1953) were updated and are shown in Figures 12 through 15.

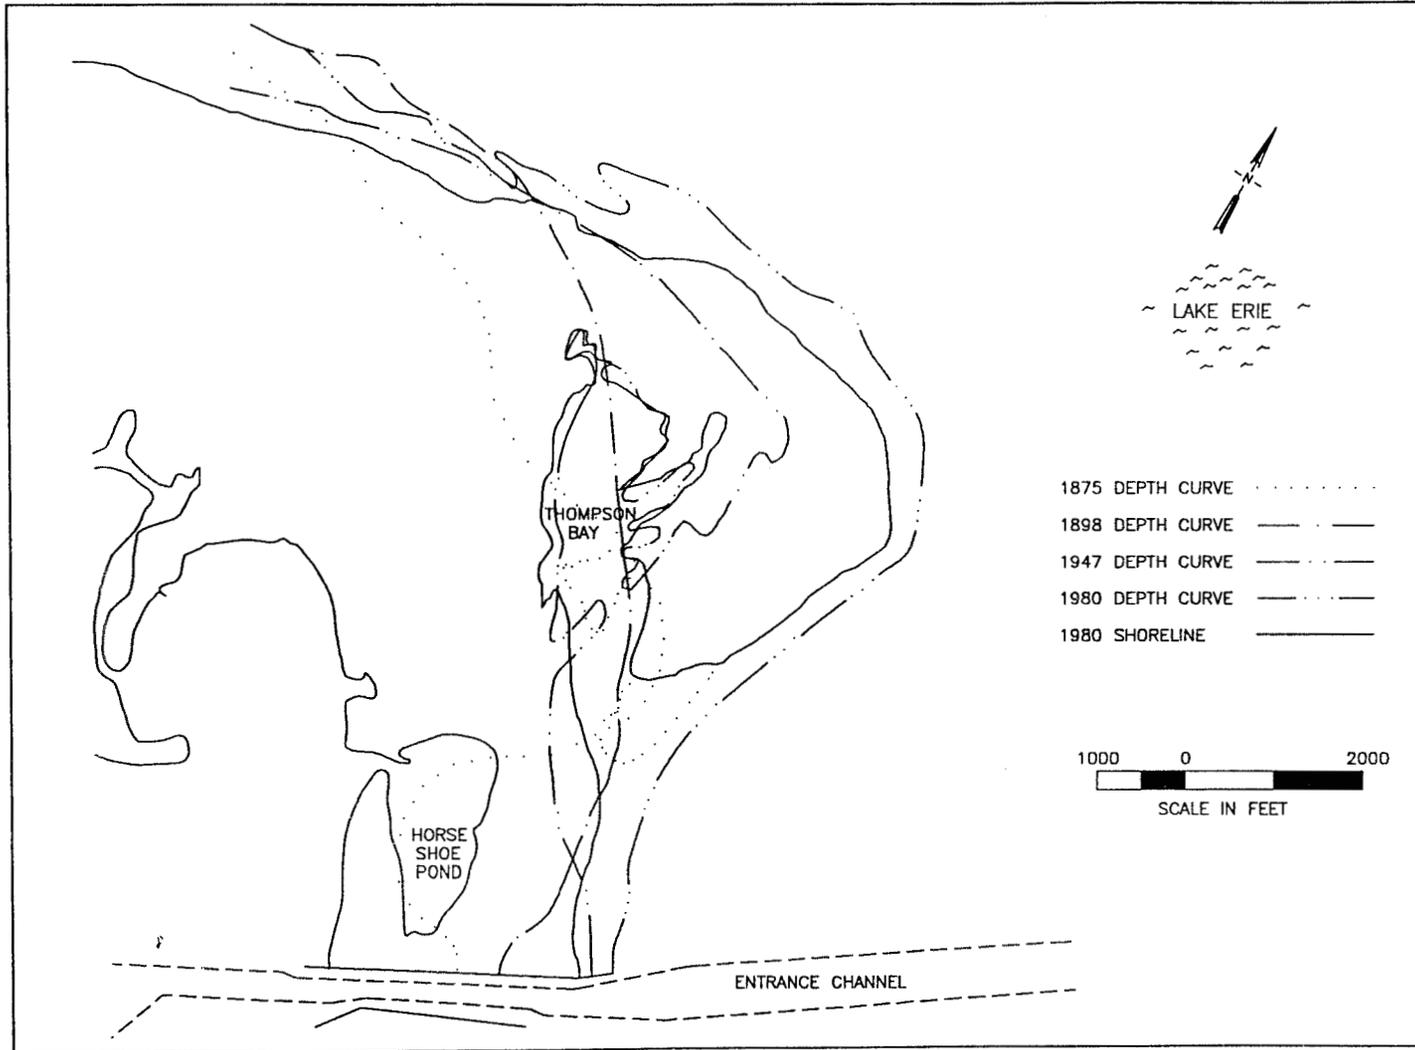
Figure 13. Presque Isle eastern 12-ft contour changes (1875-1980) (modified from USAED, Buffalo (1986))

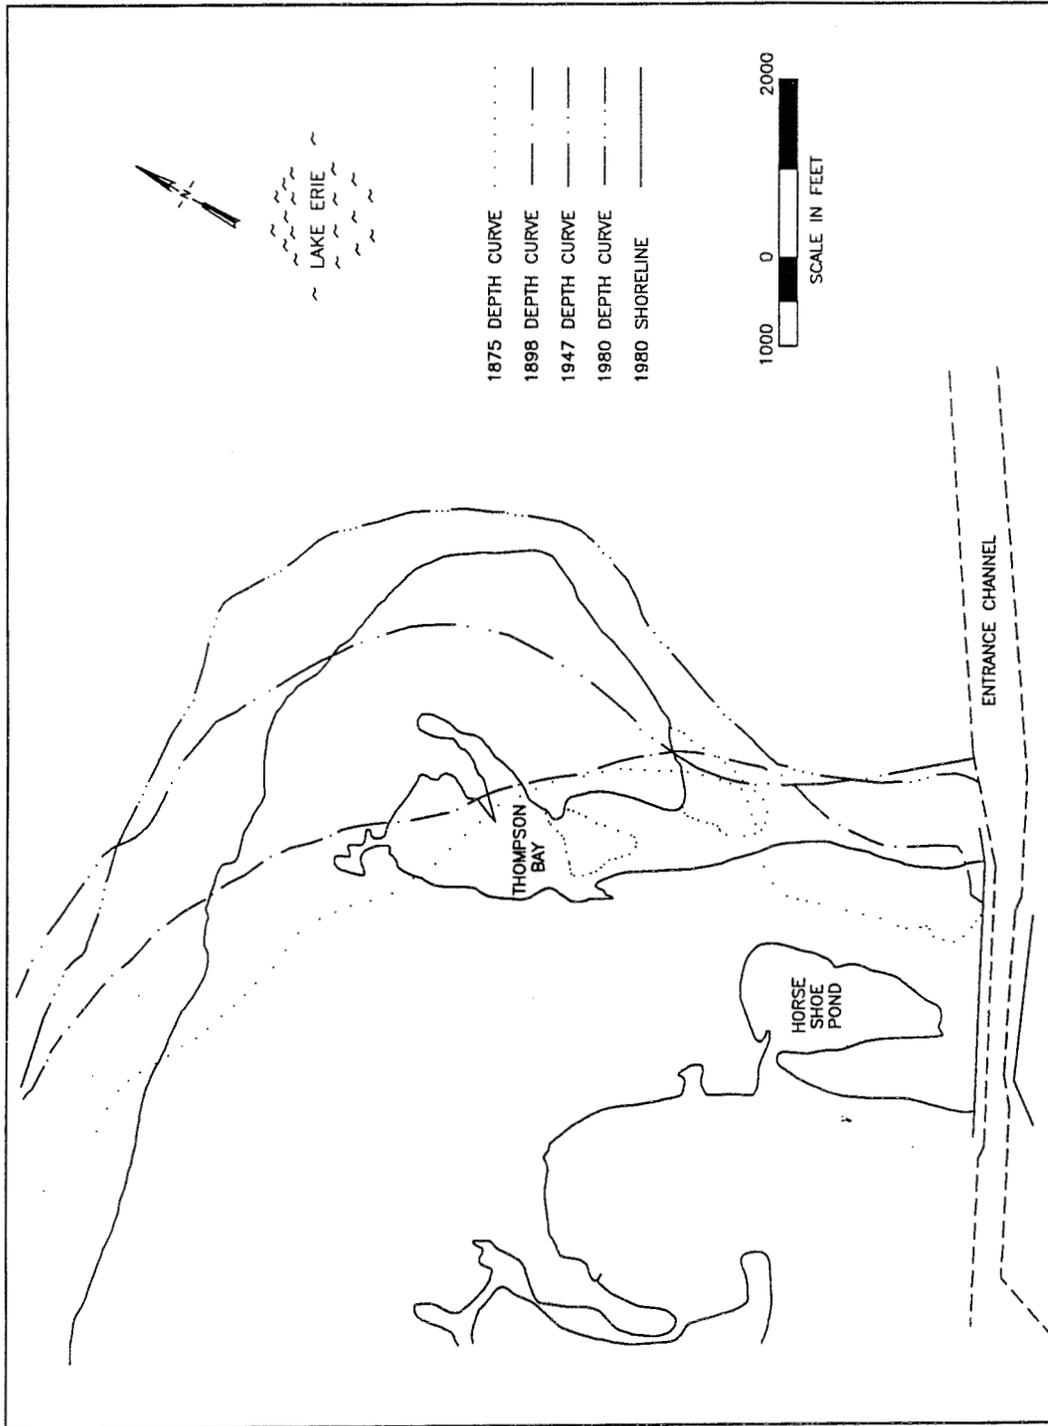
Figure 14. Presque Isle eastern 18-ft contour changes (1875-1980) (modified from USAED, Buffalo (1986))

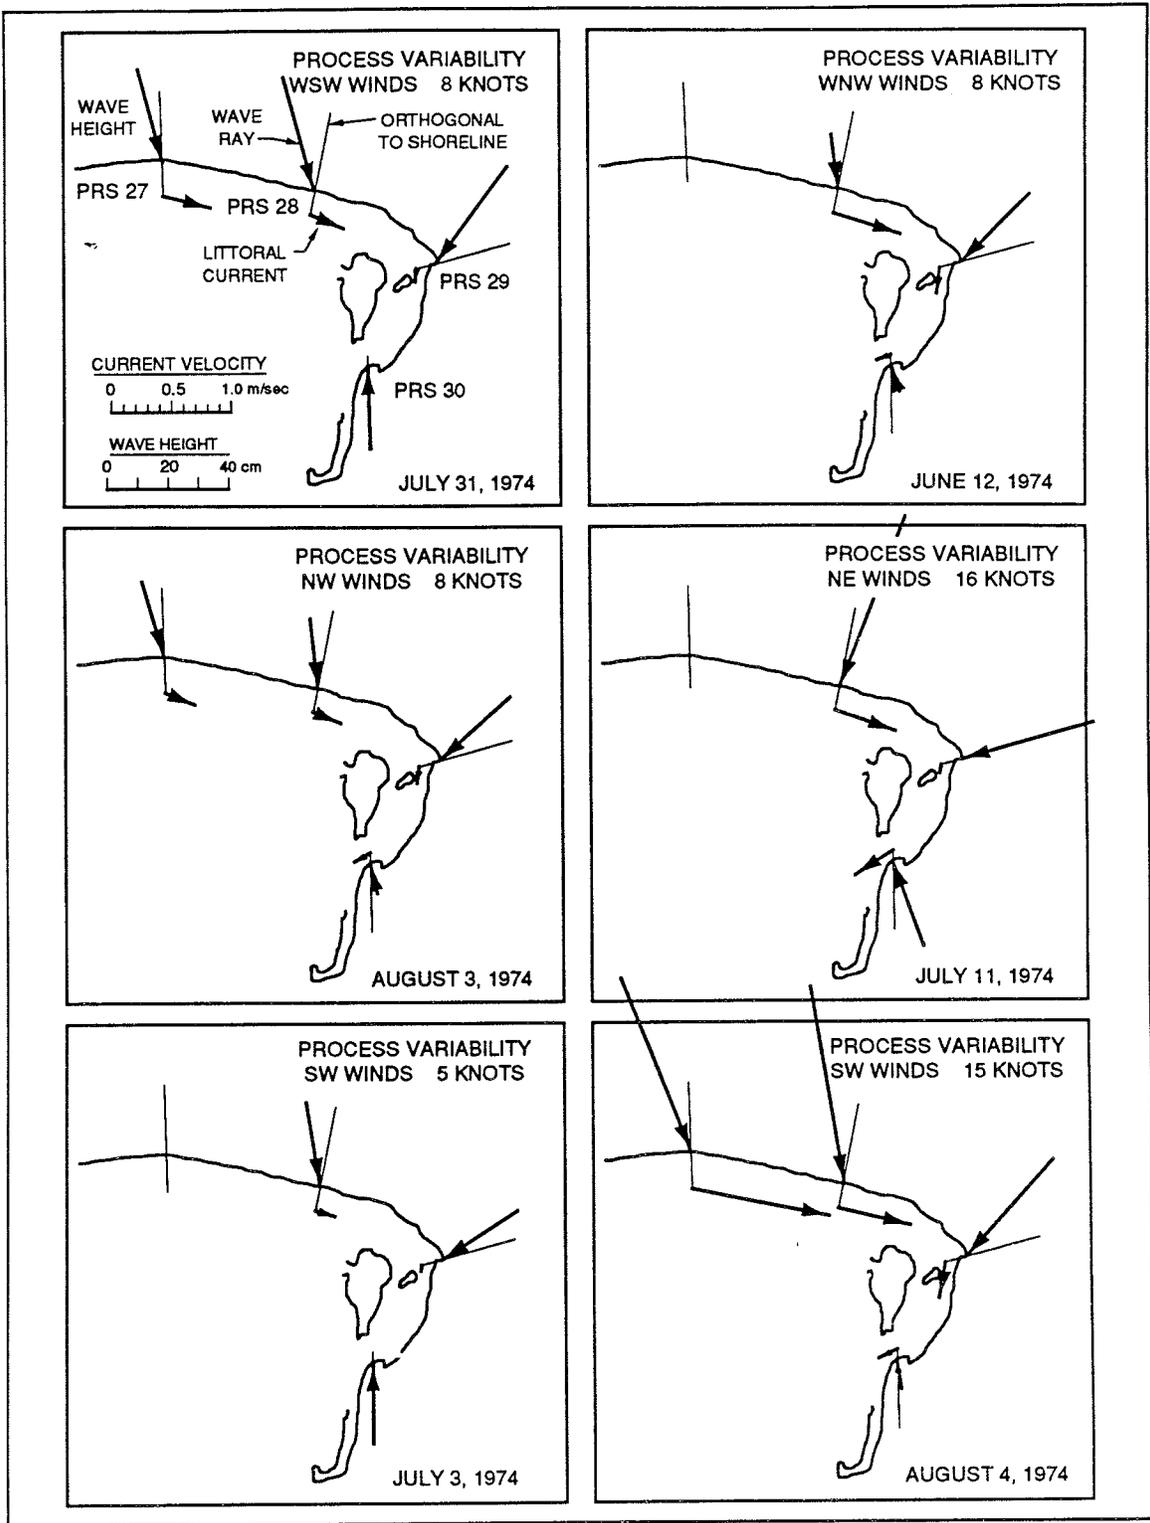
Figure 16. Observed wave height and longshore current velocity for various wind speeds and directions at Gull Point (modified from Messinger (1977))

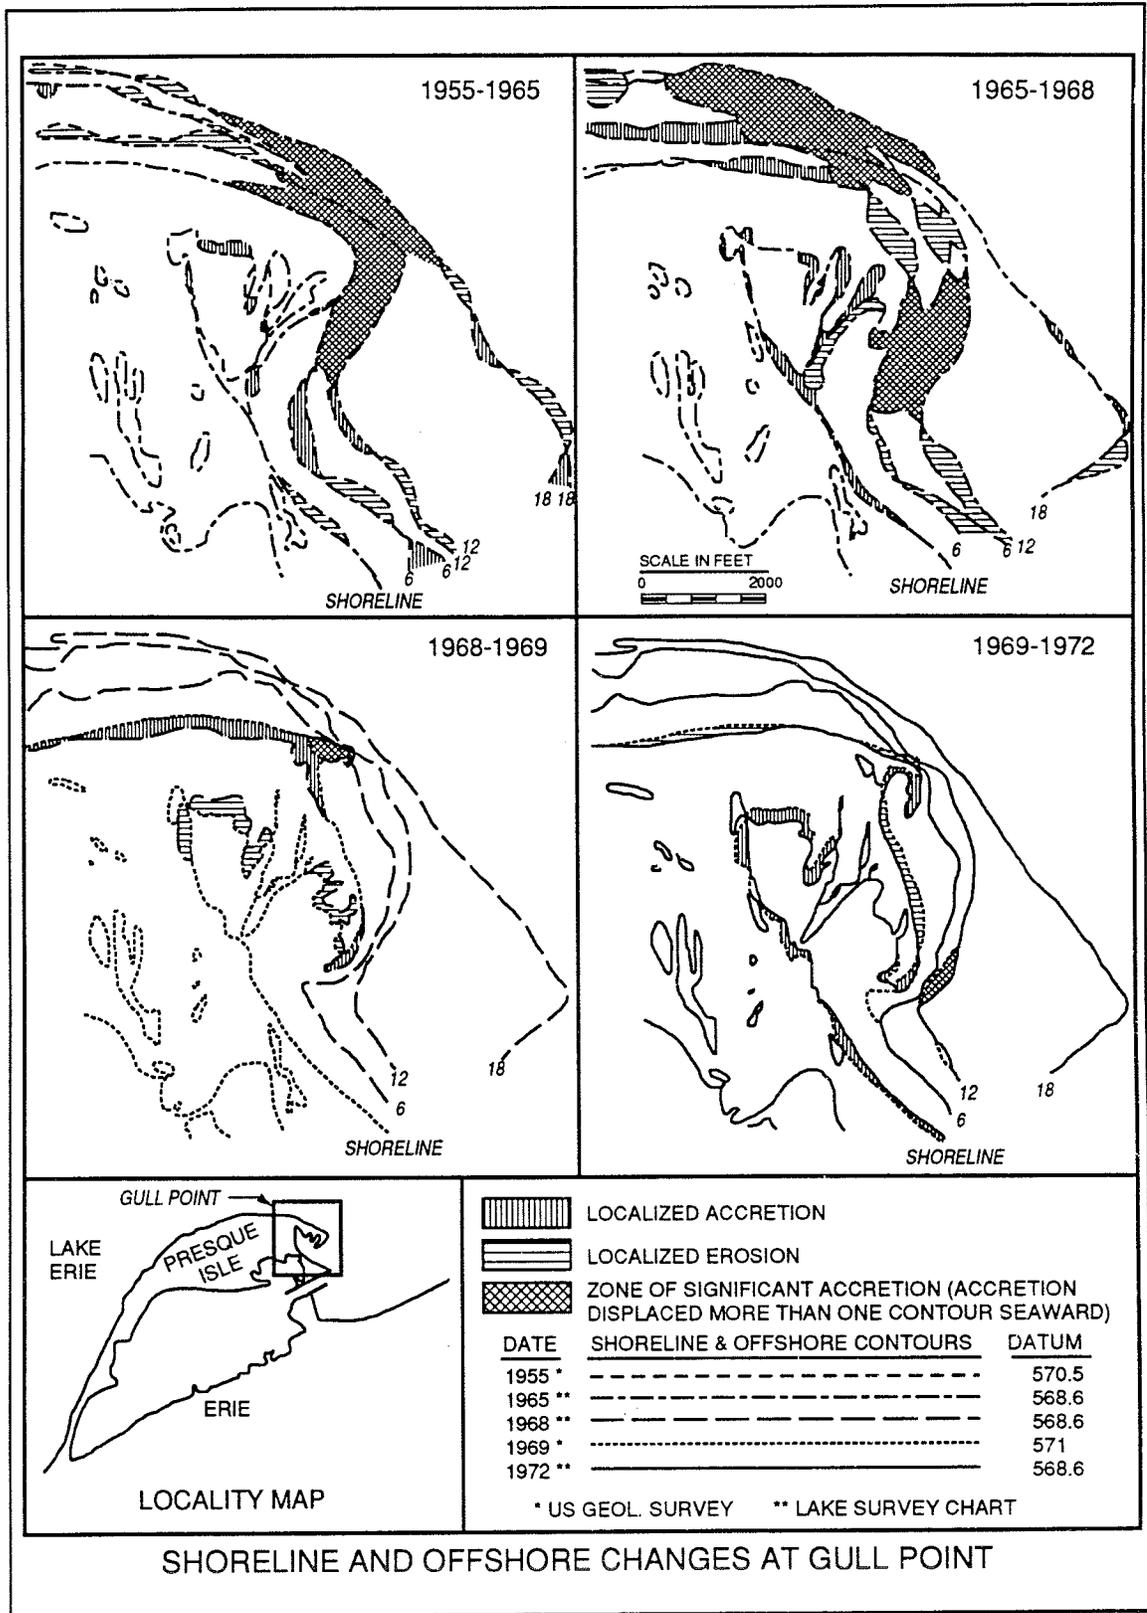
Figure 17. Growth of Gull Point from 1955 to 1972 (modified from Messinger (1977))

The growth of Gull Point, which has accelerated within recent times due to the beach nourishment program, is shown on Figures 17 through 19. Growth of Gull Point during the period from 1955 to 1972 (Figure 17) was greatest during the mid 1960's probably in response to the over 5,000,000 cu yd of sand that were placed on the peninsula beaches during construction of the initial beach erosion control project and early beach nourishment phases of the 1960's. During the period from 1975 to 1991, beach nourishment has been carried out on an annual basis to the order of about 160,000 to 185,000 cu yd per year. This has resulted in dramatic growth of Gull Point and the offshore platform (Figures 18 and 19) with dredging quantities in the Erie Harbor entrance channel increasing by about 4,400 cu yd per year. Continuation of the annual nourishment program at the present rate will continue to result in greater annual maintenance costs to Erie Harbor and will shorten the time frame of Gull Point/offshore platform advance to the entrance channel.

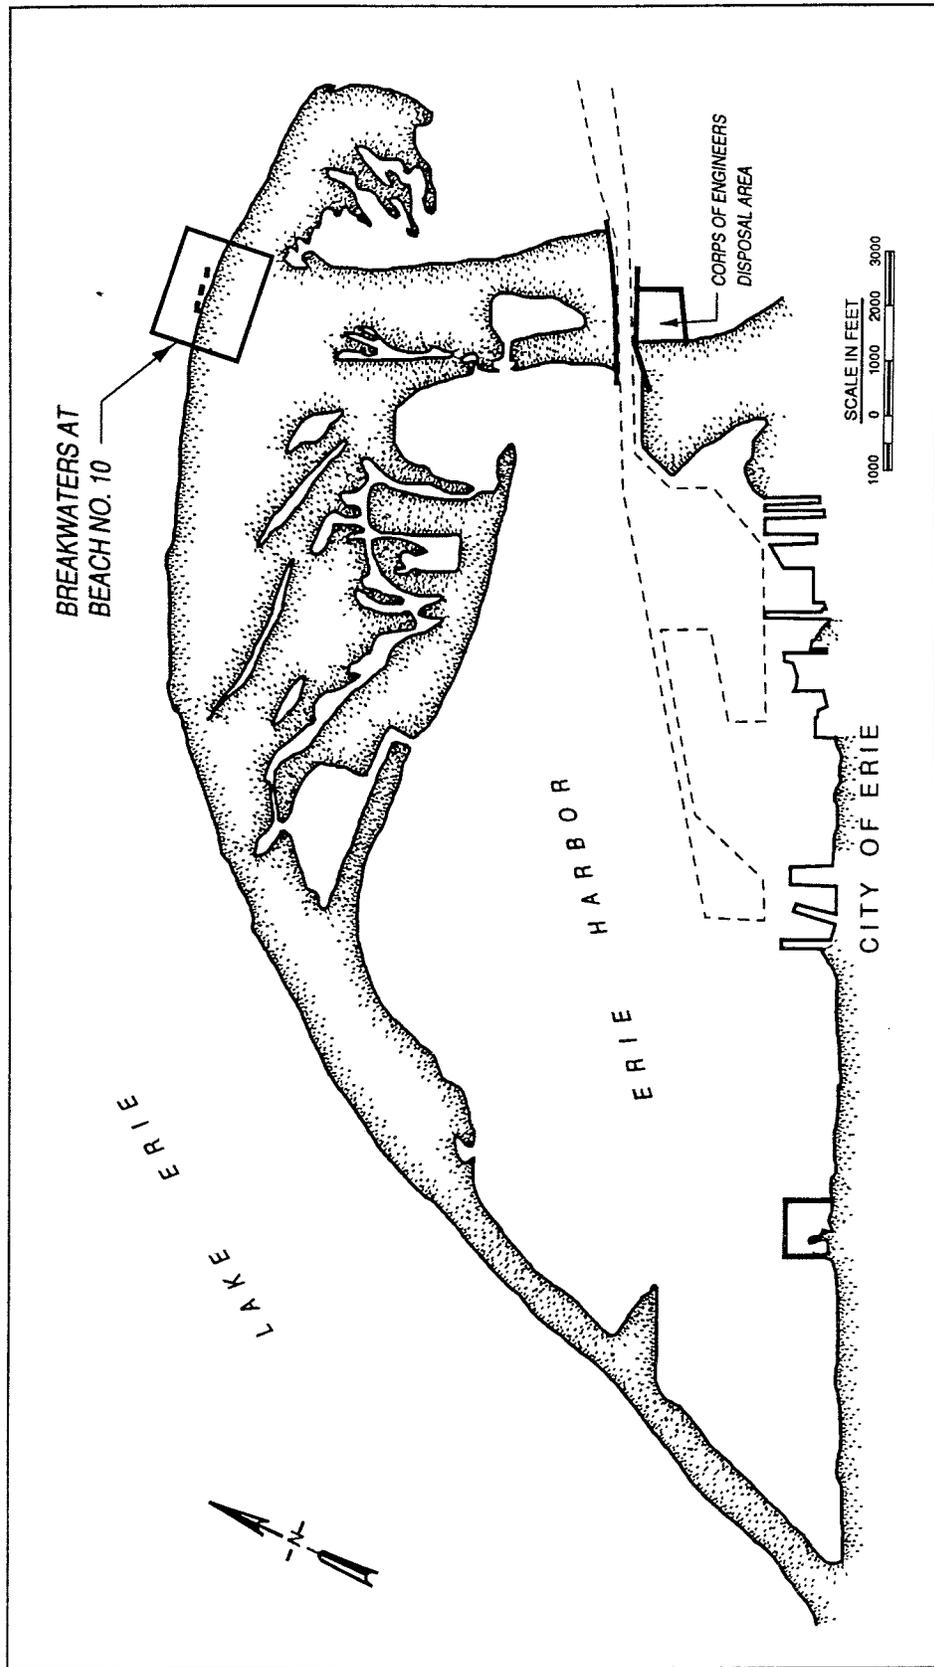
Figure 20. Location of Beach No. 10, Presque Isle (modified from Gorecki (1985))

Three rubble-mound breakwaters were constructed in June 1978, and 70,000 tons of sand were spread along the shoreline behind the breakwaters. Each breakwater, aligned parallel to the peninsula shoreline, is 125 ft long, 6 ft high, and separated by gaps of 300 ft and 200 ft. The two spacings between the prototype breakwaters were selected to provide additional information on determining an optimum gap to allow swimming between the
